**MERRIMACK RIVER BASIN
MANCHESTER, NEW HAMPSHIRE**

HIGH SERVICE DISTRIBUTION RESERVOIR

**PHASE I INSPECTION REPORT
NATIONAL DAM INSPECTION PROGRAM**

APRIL 1979

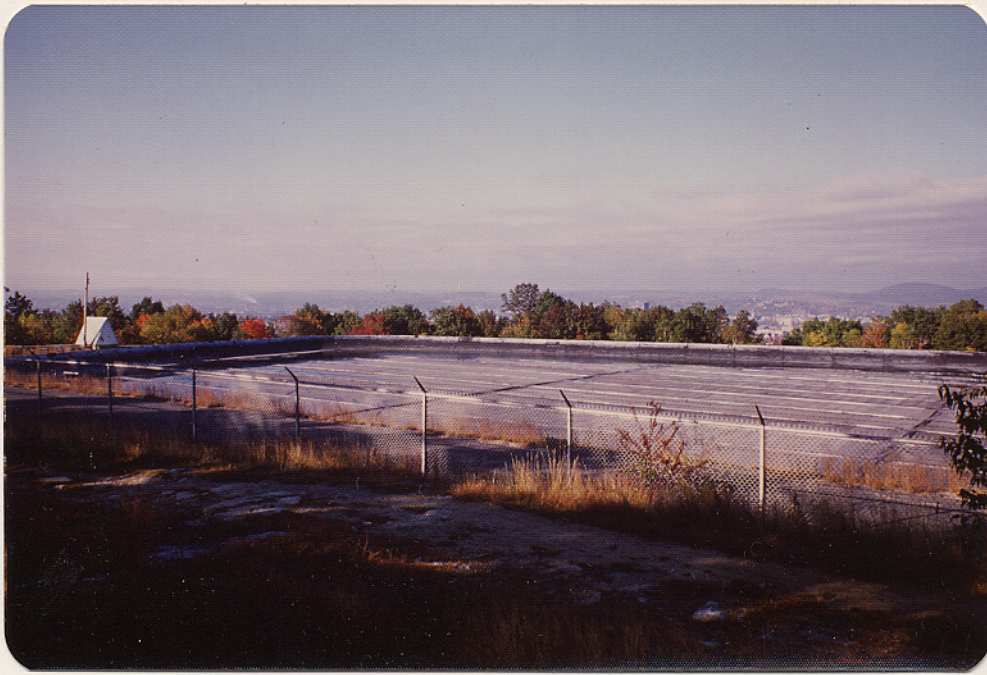
Overview of reservoir from east side looking
towards Manchester

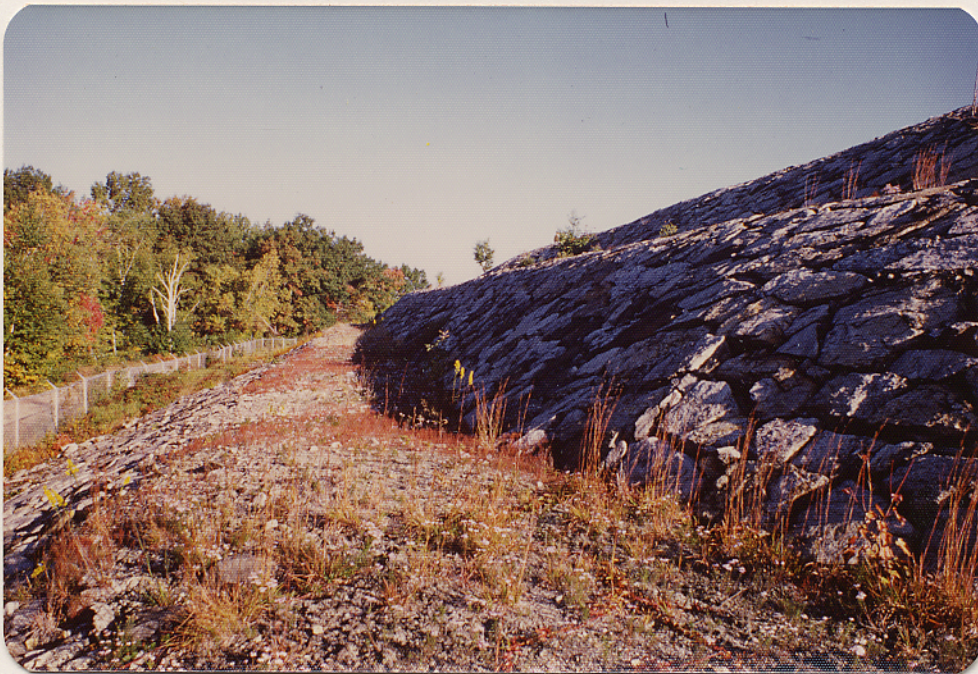
Overview of tiers on west side from toe
of embankment

The west embankment is in good condition (overview photo). No significant areas of sloughing of the rock slopes are visible. The rock face is smooth with occasional small shrubs or trees growing in this slope. The lower berm at the southwest corner of the embankment has some depressions and some erosion of fines over the slope.

- (b) Remove all shrubs, trees and their roots from the slopes of the embankments and backfill with suitable well compacted fill.
- (c) Formalize the inspection performed during the weekly site visits to include a routine that the inspector should follow. This may include a checklist of items that should be observed.
- (d) Repair the embankment on the south side where some erosion and settlement has occurred.
- (e) Retain the current annual detailed technical inspection and review system with particular attention to future seepage that may occur.
- (f) Institute a formal written emergency warning system to notify downstream residents in case hazardous conditions should arise at the reservoir.
- (g) Backfill animal burrows.

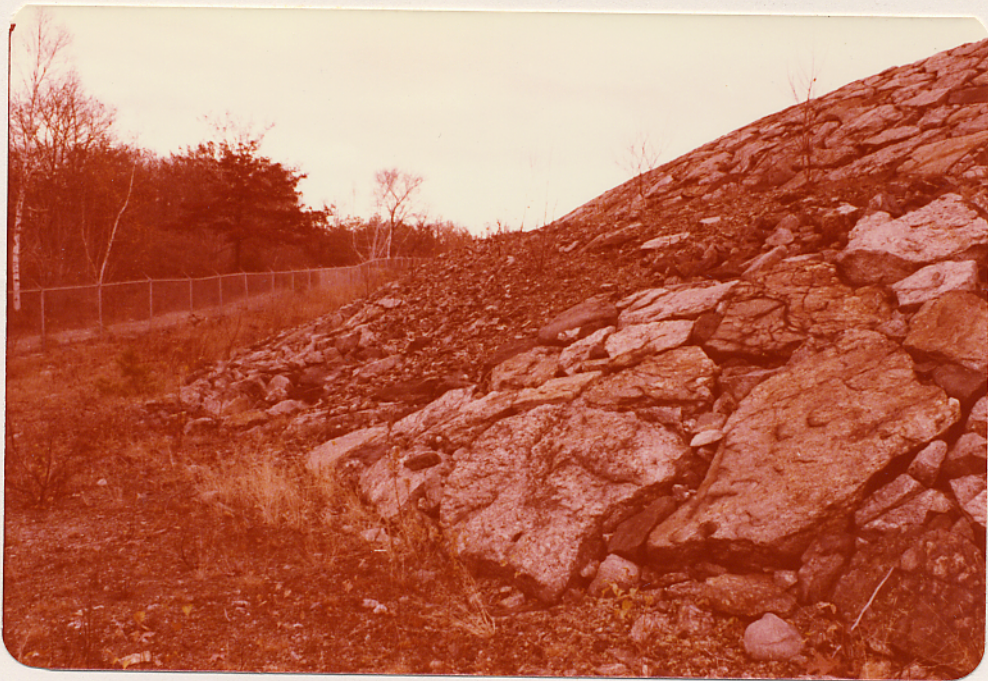
1. View of north side of reservoir showing poorer quality of slope protection at end of second tier

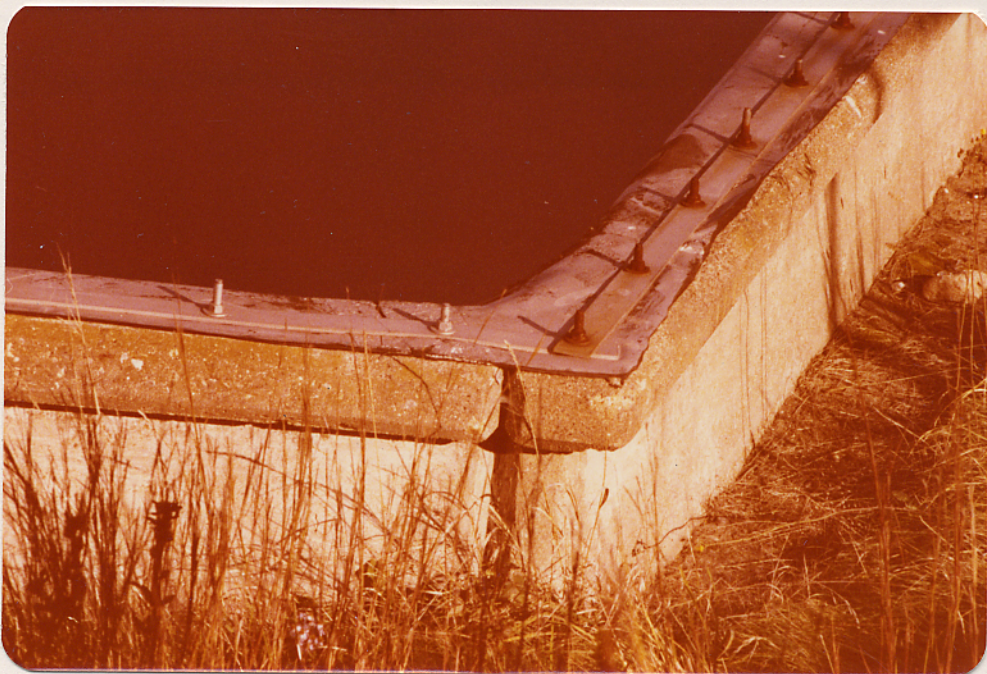
The surface of the reservoir is kept covered with either a neoprene or butyl rubber protective cover fastened to pontoons to protect treated water from contamination. The cover is fastened to the top of the perimeter parapet wall with a series of anchor bolts which hold down a steel plate over the cover. Photo No. 2 in Appendix C shows a detail of this connection.

Minor concrete spalling was noted at some vertical expansion joints around the perimeter of the structure (Photo 2). Vertical and horizontal effloresced hairline cracks were also observed at some locations. The joint spalls and minor cracking are attributed to temperature changes. An expansion joint in the parapet wall, located at the southwest corner, is completely distorted. The distortion is a result of faulty construction, but this does not appear to be a detriment at this time. Spalling has occurred adjacent to the joint.

2. Detail of concrete lining and rubber membrane cover

- (a) Repair the spalled concrete observed on the concrete portions of the reservoir.

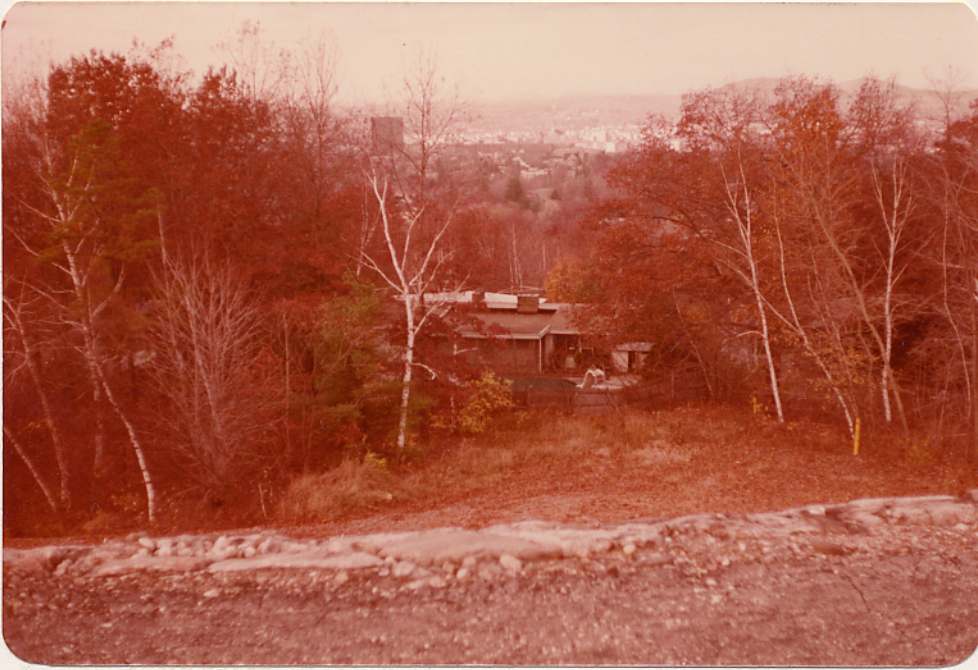
3. Overview of area downstream of west side
of reservoir from top of embankment
